Name and Location of Facility Inspected Former Jackson Mercury Mine Sonoma County APN 069-060-035 APN 069-060-033	Facility Permit N/A Closed in May 1972	Inspection Date June 3, 2016	Inspection Time 10:00 AM
Names & Titles of On-Site Representatives and Consenting Parties	Consent Provided?	Contact Information	Notified of Inspection?
Mr. David Reed Mr. James Henry and family	<input checked="" type="checkbox"/> Yes	Phone: 707 570-6632 (Reed) 707 953-6206 (Henry)	<input checked="" type="checkbox"/> Yes
Property Owner(s)		Address:	
Mr. David Reed		18045 Sweetwater Springs Road, Guerneville	
Mr. James Henry and family		18001 Sweetwater Springs Road, Guerneville	
WQ Inspector Name(s) & Title(s) Lindsay Whalin, Engineering Geologist, Regional Water Board, Region 2 Jon Mistchenko, Engineering Geologist, Department of Conservation Claudia Villacorta, Supervising Engineer, Regional Water Board, Region 1 Paul Keiran, Water Resource Control Engineer (WRCE), Regional Water Board, Region 1

I. Background

II. Inspection observations

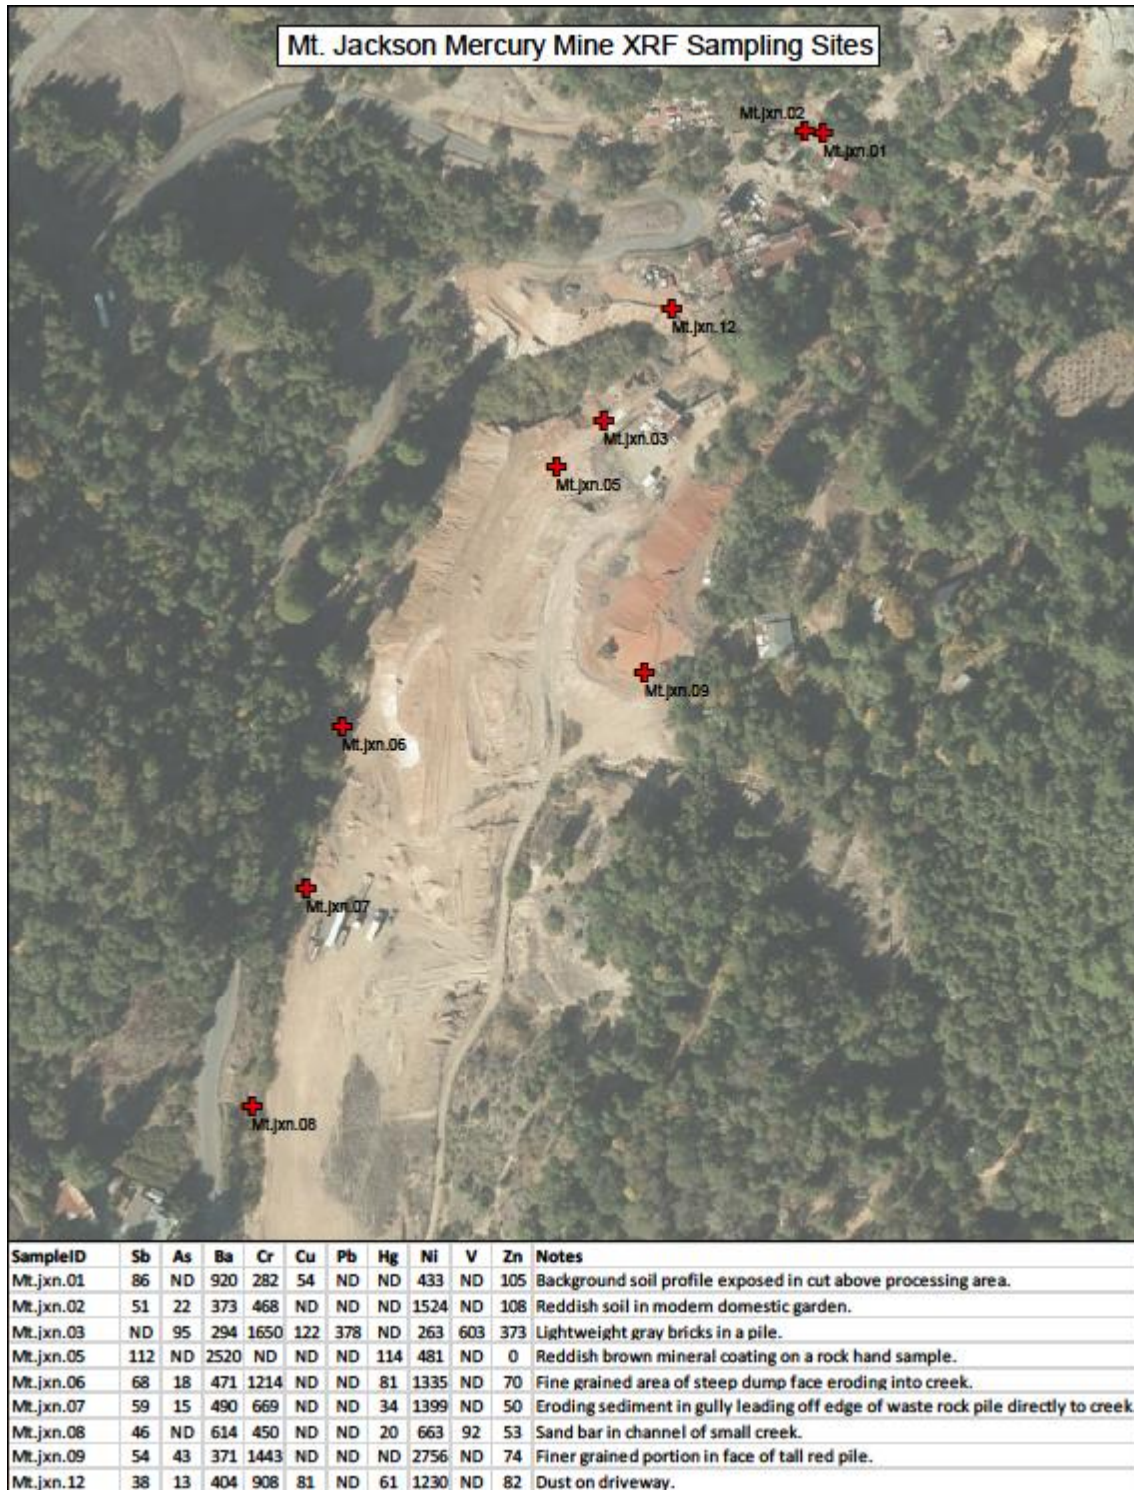
III. Site map showing sampling sites

The following map details the sampling sites and associated metals concentrations for 10 species of metals.

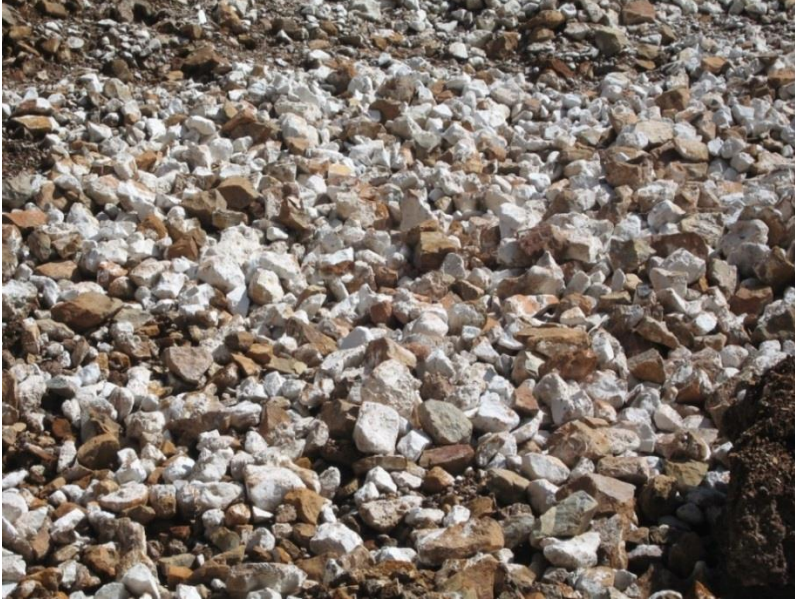
Photo 1: Typical mine waste rock at Jackson Mercury Mine

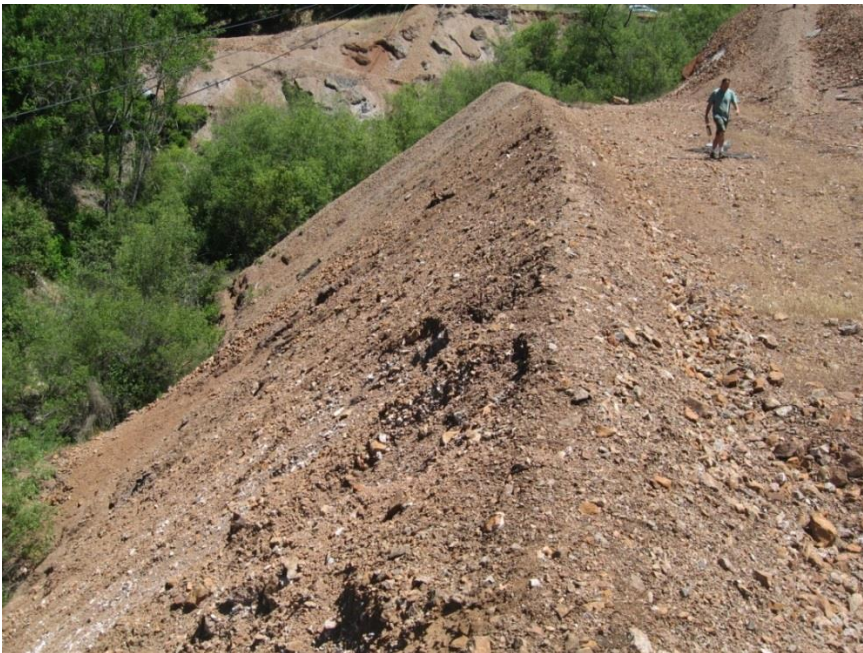
Photo 2: Mine waste pile adjacent to Wilson Creek

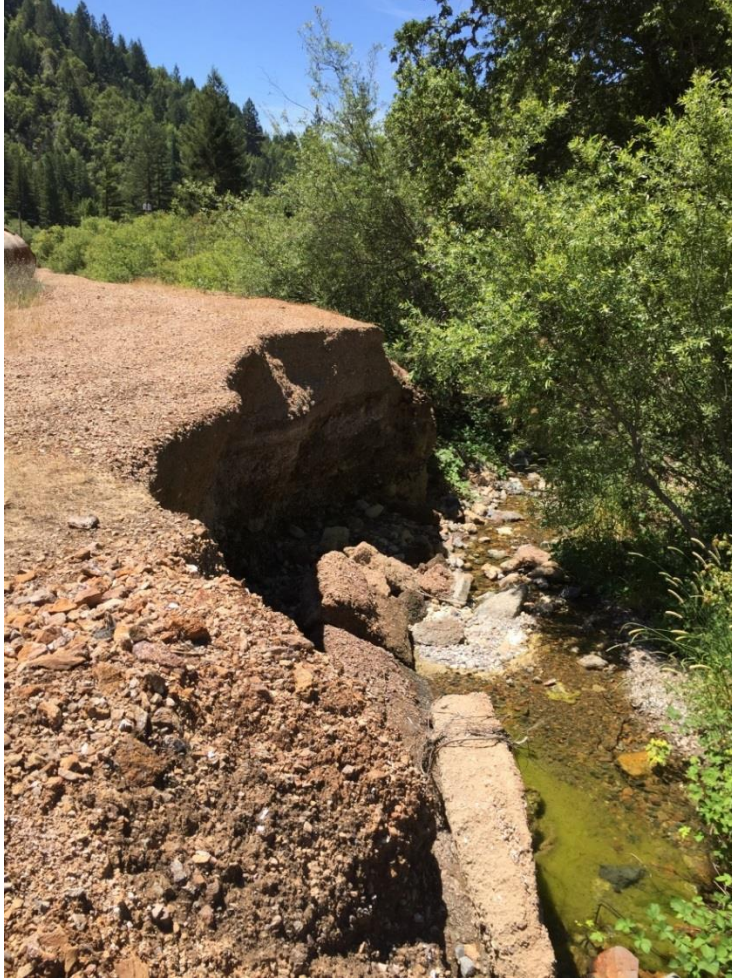
Photo 3: Mine wastes cleaving off side slope into Wilson Creek

The riparian areas and creek bank, mostly on the south side but also in places on the north side of the creek, appeared to consist primarily of mine wastes interspersed with willows. The three XRF samples taken of fines in these creek bank soils, above the ordinary high water line, indicated concentrations of mercury above hazardous waste thresholds. This is of concern due to these fines eroding into the creek. In addition, mining wastes were evident in the creek bed. No samples of sediments in the creek bed were collected for analysis. It is known that acid mine drainage is not an issue at this site as the mine is over 1500 feet deep and does not have any surface discharges.

Further investigation of the Jackson Mercury mine may be warranted given the identification of elevated concentrations of mercury in the creek bank soils, which were eroding into the creek during periods of precipitation. A characterization of mercury concentration in soils that are eroding to the creek could quantify potential water quality

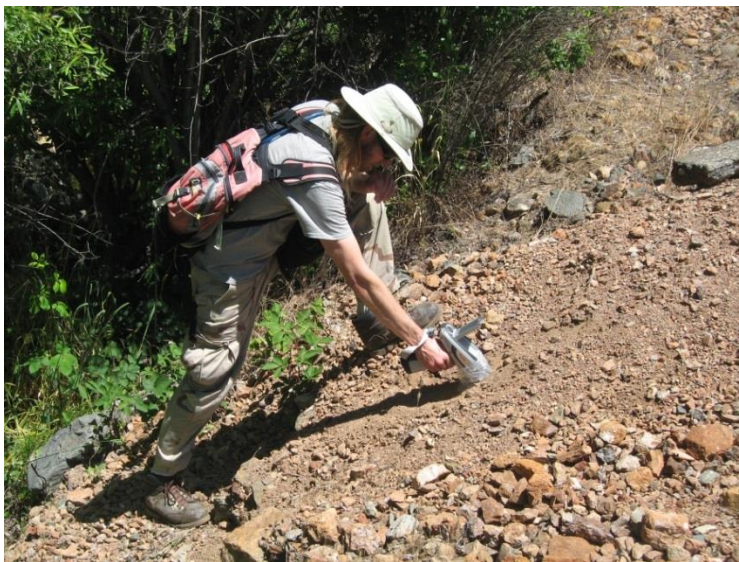
Photo 4: Sampling drainages adjacent to Wilson Creek.

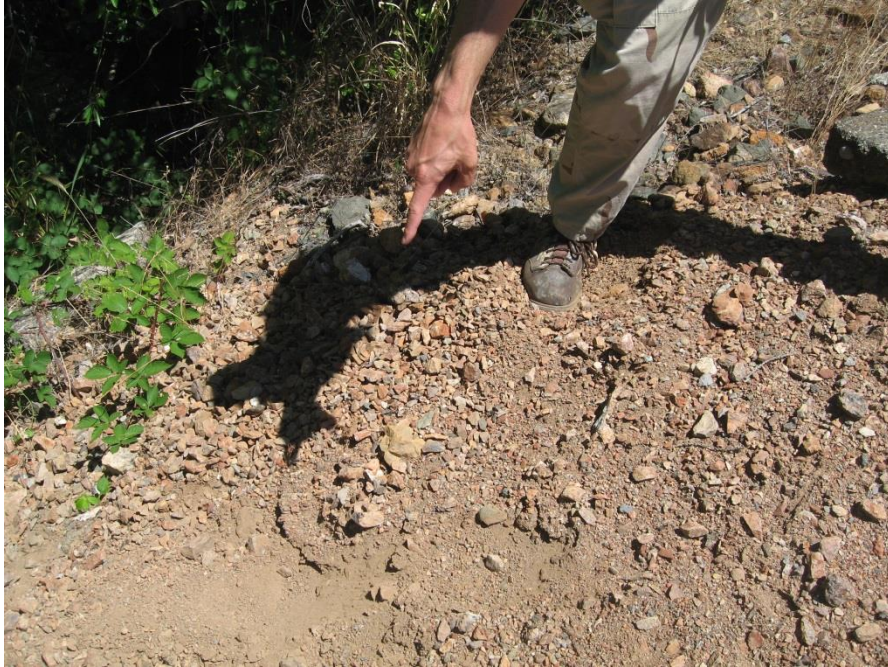
The bulk of storm water flows directly into Wilson Creek via several well defined drainages. The fines that were sampled in these drainages revealed the presence of total mercury and other total metals. Other sources of mercury were detected in driveway dust (see Photo 5) and in one area where rocks with a reddish brown mineral coating were noted (see Photo 6). Concentrations of mercury higher than 20 mg/kg are considered hazardous. The highest concentrations of mercury found onsite were at sample site Mt.jxn.05 (114 mg/kg), followed by Mt.jxn.12 (81 mg/kg), Mt.jxn.06 (61 mg/kg), Mt.jxn.07 (34 mg/kg), and Mt.jxn.08 (20 mg/kg). Four other sampling points revealed mercury as non-detect, albeit these areas did reveal evidence of other detected metals. A review of Department of Toxic Substances Control Criteria for Inorganic Constituents of Hazardous Wastes (see Attachment 1) for these metals shows that 4 out of the 9 mercury samples collected show total threshold limit concentrations (TTLC) of mercury that are four to five times higher than the Mercury TTLC limit in soil of 20 mg/kg. No other metals showed levels that exceeded their TTLC limit (See Attachment 1 for list of TTLC limits).

Photo 5: Eroded fines adjacent to Wilson Creek

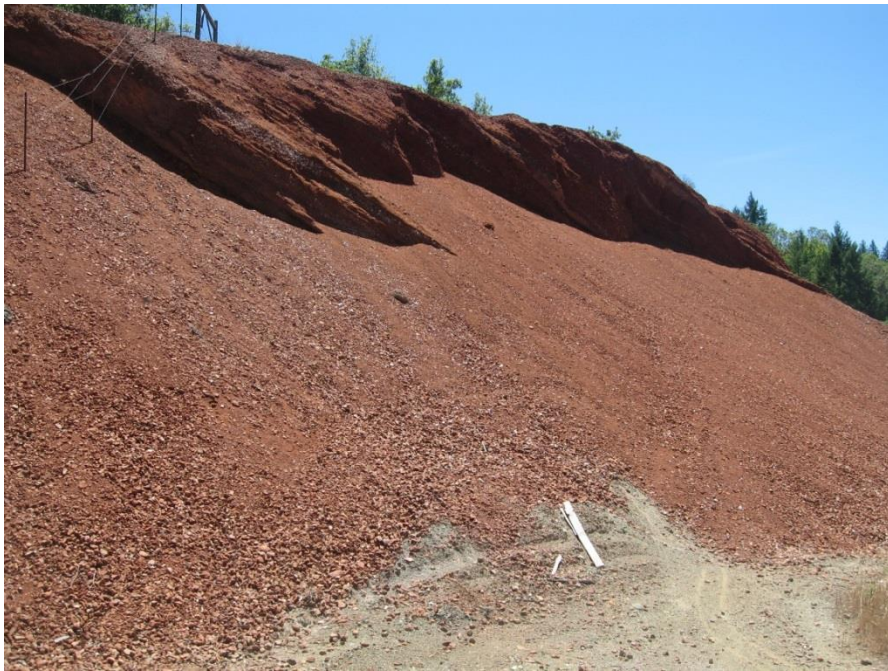
Photo 6: Upper area mine waste pile

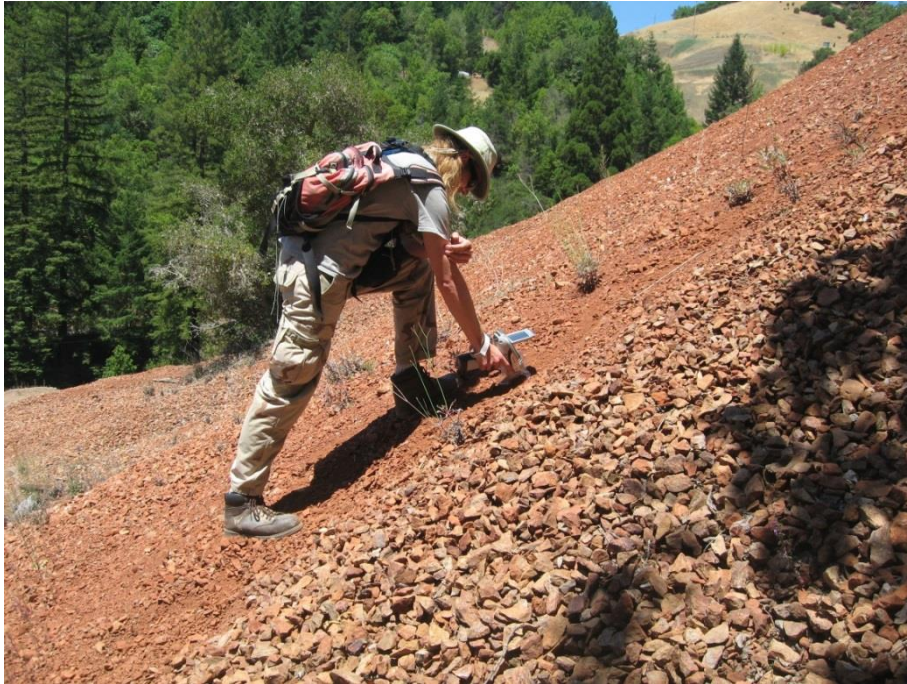
Photo 7: Sampling upper (red) mine waste pile

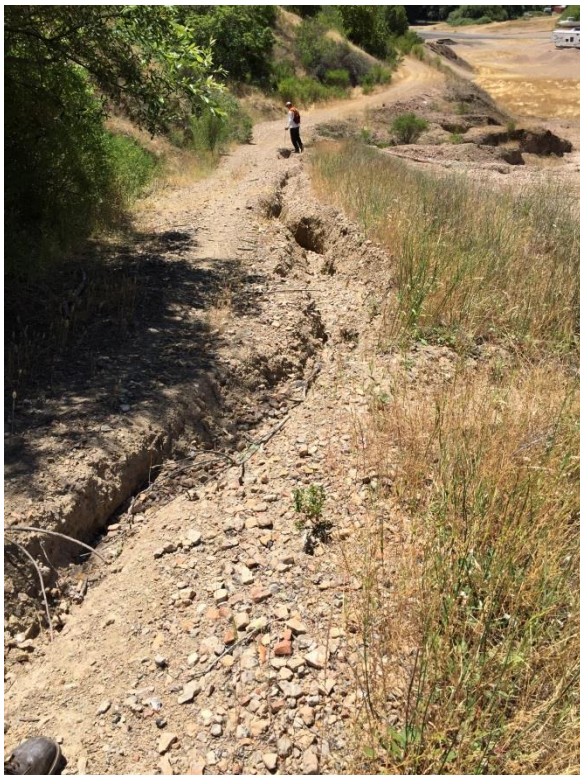
Photo 8: Upper area drainage

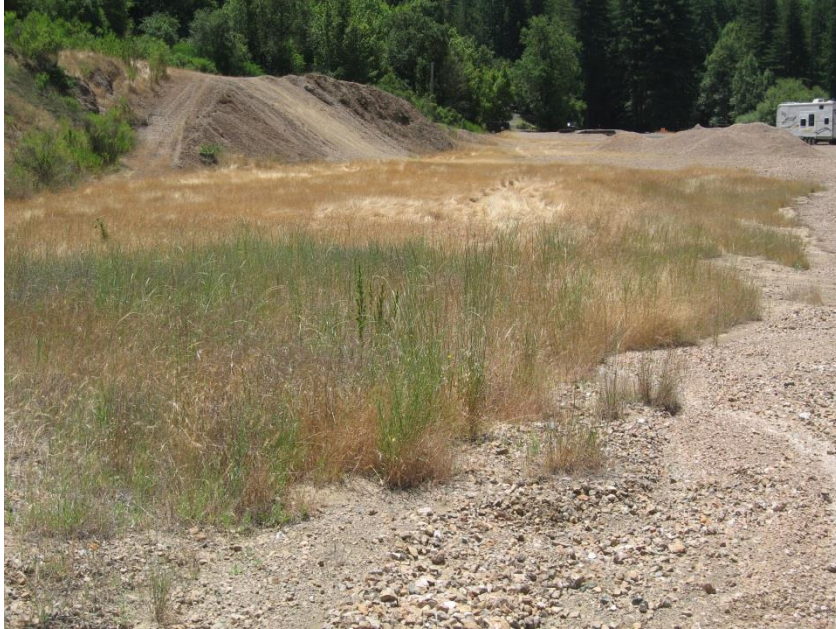
Photo 9: Evidence of vegetative growth where soils aggraded

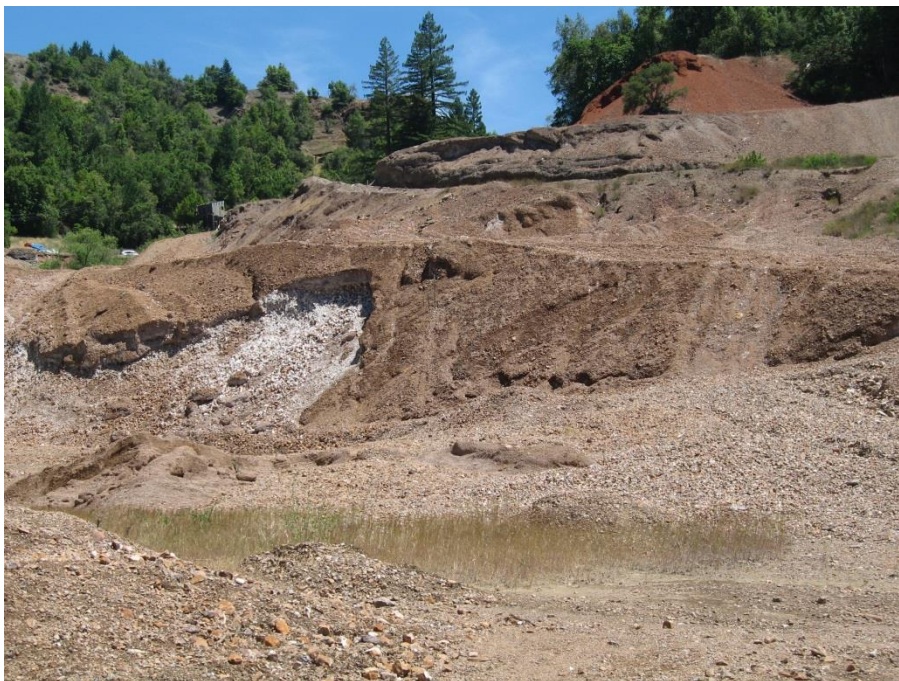
Photo 10: view of upgradient mine waste piles

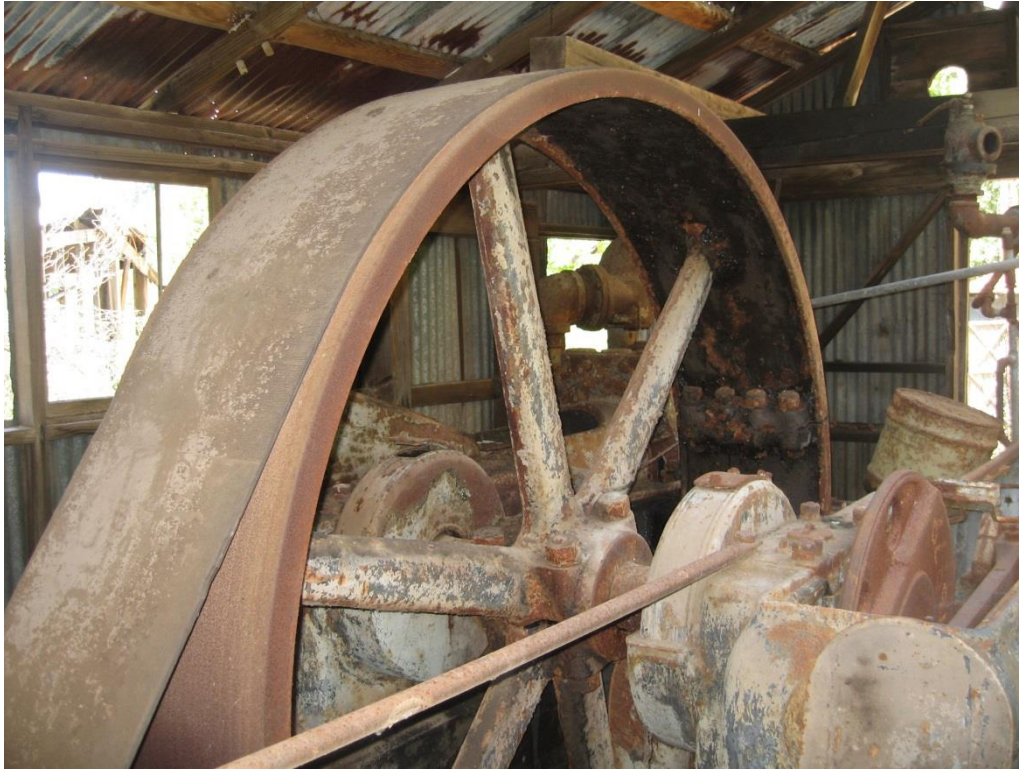
Photo 11: Steam generation power plant flywheel

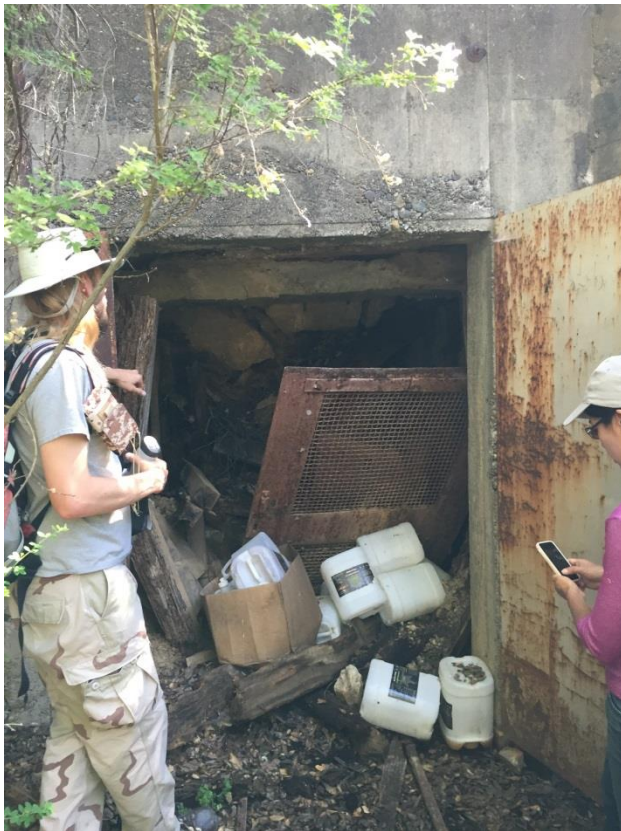
Photo 12. Mine shaft entrance

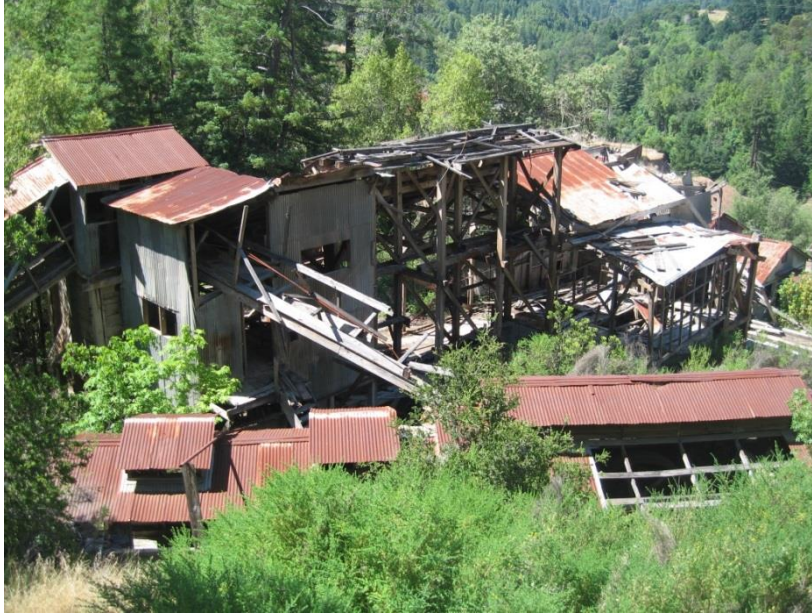
Photo 13. Former ore processing zone
